BLAST CAPACITY EVALUATION OF SINGLE REVETTED BARRICADES.(U)

TECHNICAL REPORT 5009

# BLAST CAPACITY EVALUATION OF SINGLE REVETTED BARRICADES

NOVEMBER 1976

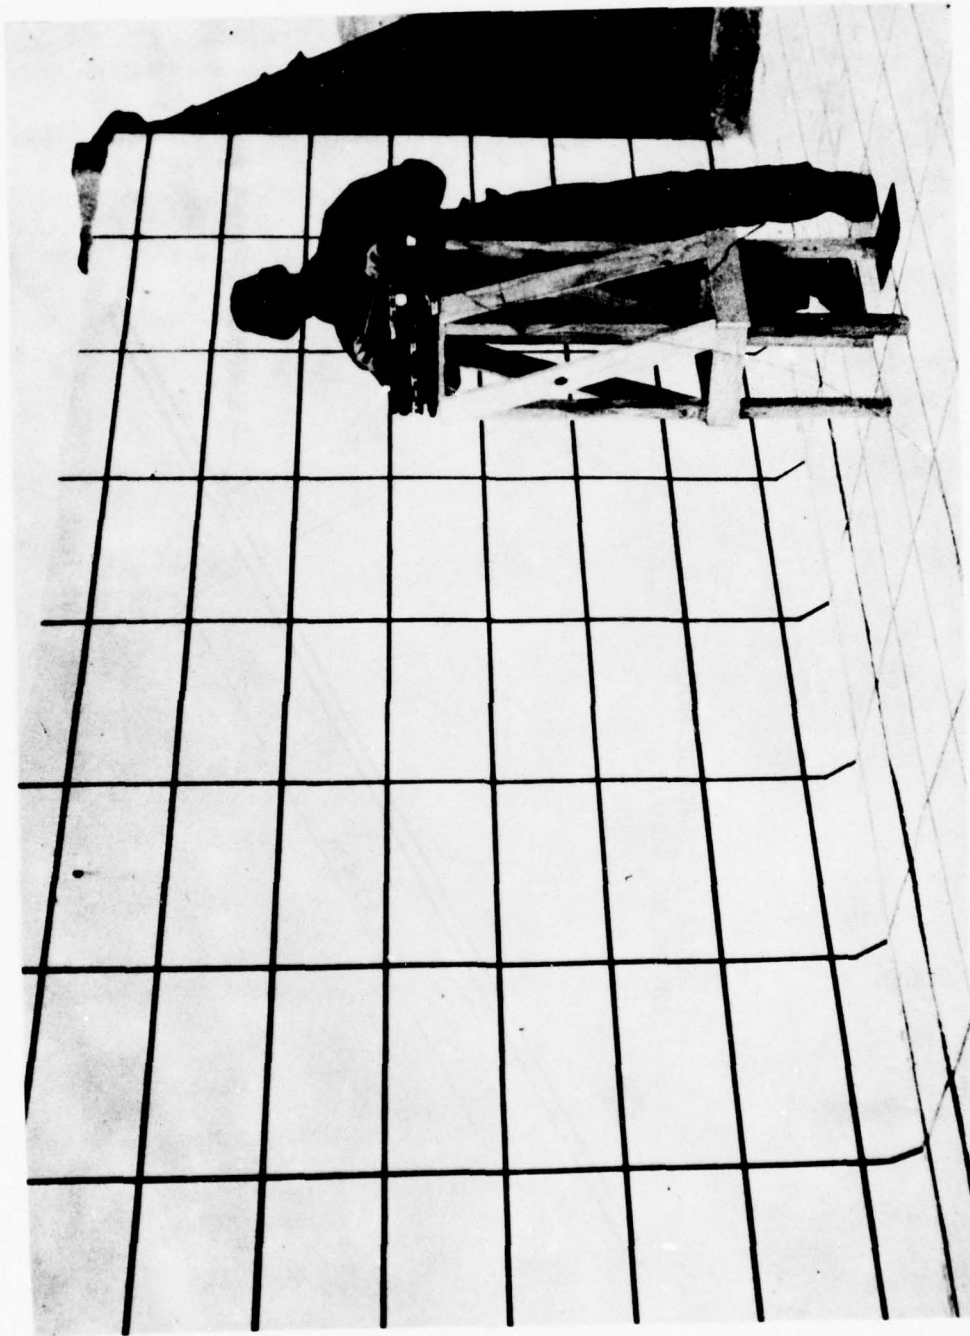
Fig 2 Test structure

Figure 2 illustrates the test structure after completion of construction while Figure 3 shows the structural details.

The damage sustained by Wall No. 1 was relatively minor (Fig 12). A small portion of the wall immediately in front of the explosion (see Figure 2 for test setup) was spalled to a depth of approximately 0.8 mm (1/32-in.). Minor hairline cracks were formed at the intersection of the top of the haunch and wall (Fig 13). Formation of these cracks indicated that the center of the wall settled relative to both ends. This settlement was attributed to the high reflected pressures produced on the floor slab immediately in front of the explosive.

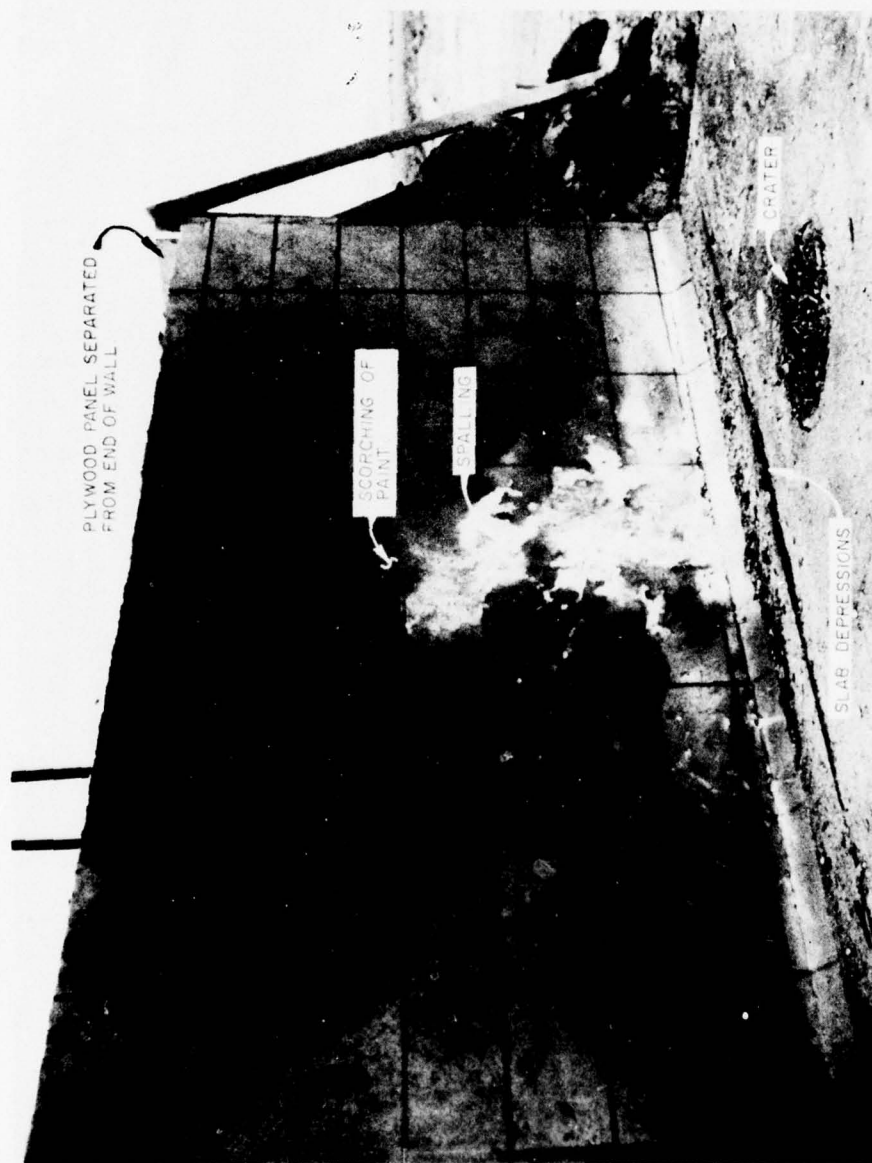
Fig 12 Front face damage, Wall No. 1, Test No. 1

Figure 12 illustrates the concrete spalling of the wall. The dark area around the spalling is attributed to the scorching of the concrete paint by the fireball. Also shown in this photo is the size of the crater formed in the non-monolithic portion of the slab. The depth of the crater did not extend the full depth of the slab. In addition to the crater formation, the non-monolithic slab was depressed downward by the blast, a greater amount than was the portion of the slab which was cast monolithic with the wall. Here, the non-monolithic slab merely acted as a slab on an elastic foundation, whereas the interaction between the monolithic slab and wall tended to span the slab loads across the wall as a beam. In actual construction, advantage should be taken of this beam action of the wall in order to reduce the overall slab depressions.

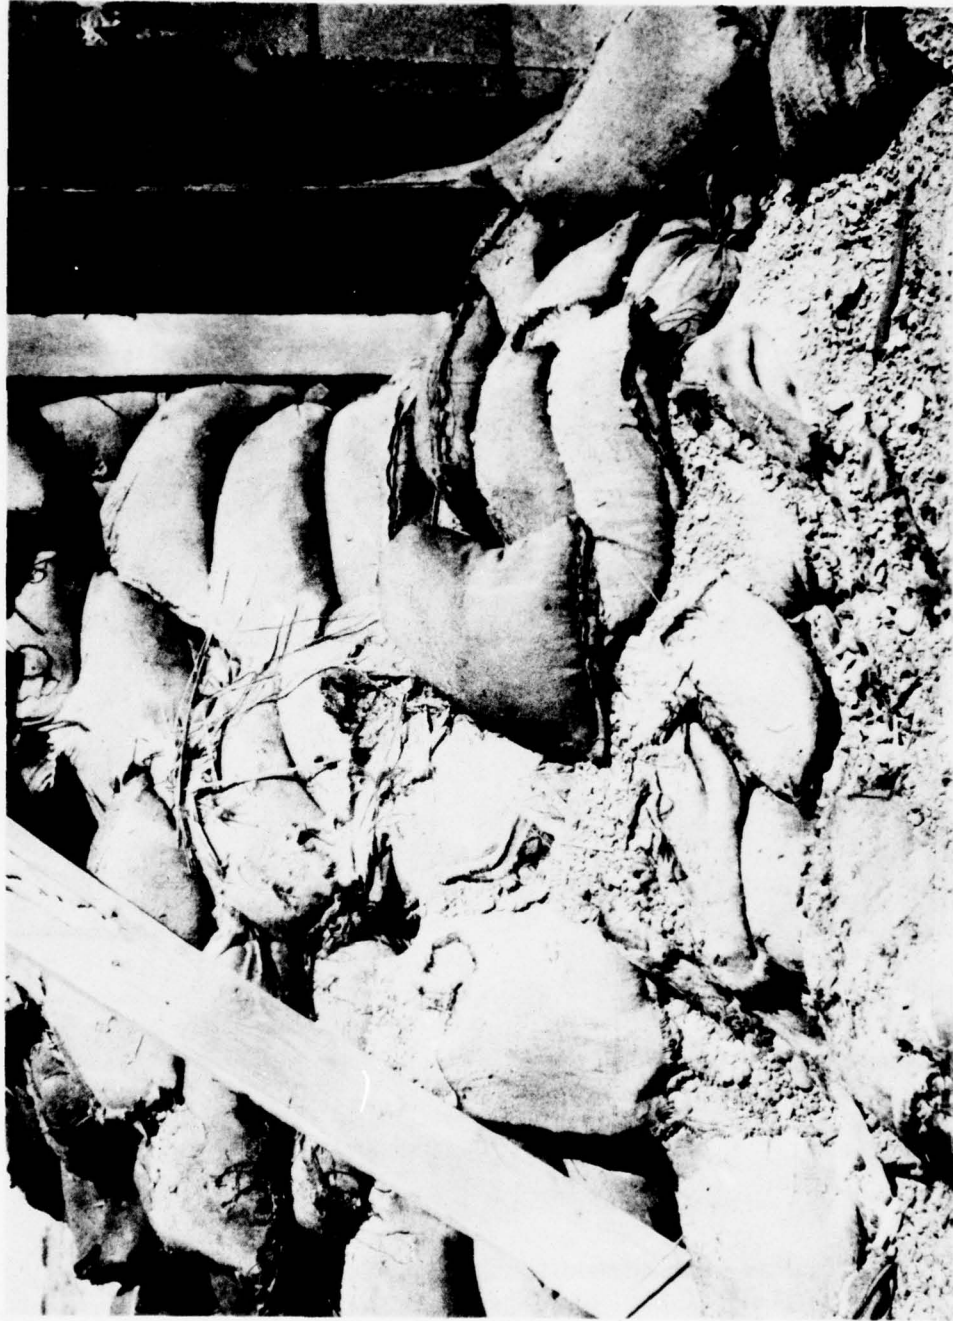
Fig 17 Sandbag and mount support damage, Test No. 2

Damage to the sandbags and wood frame was slightly increased from that of the first test (Fig 17). However, the integrity of the mound and its supports was still essentially intact.

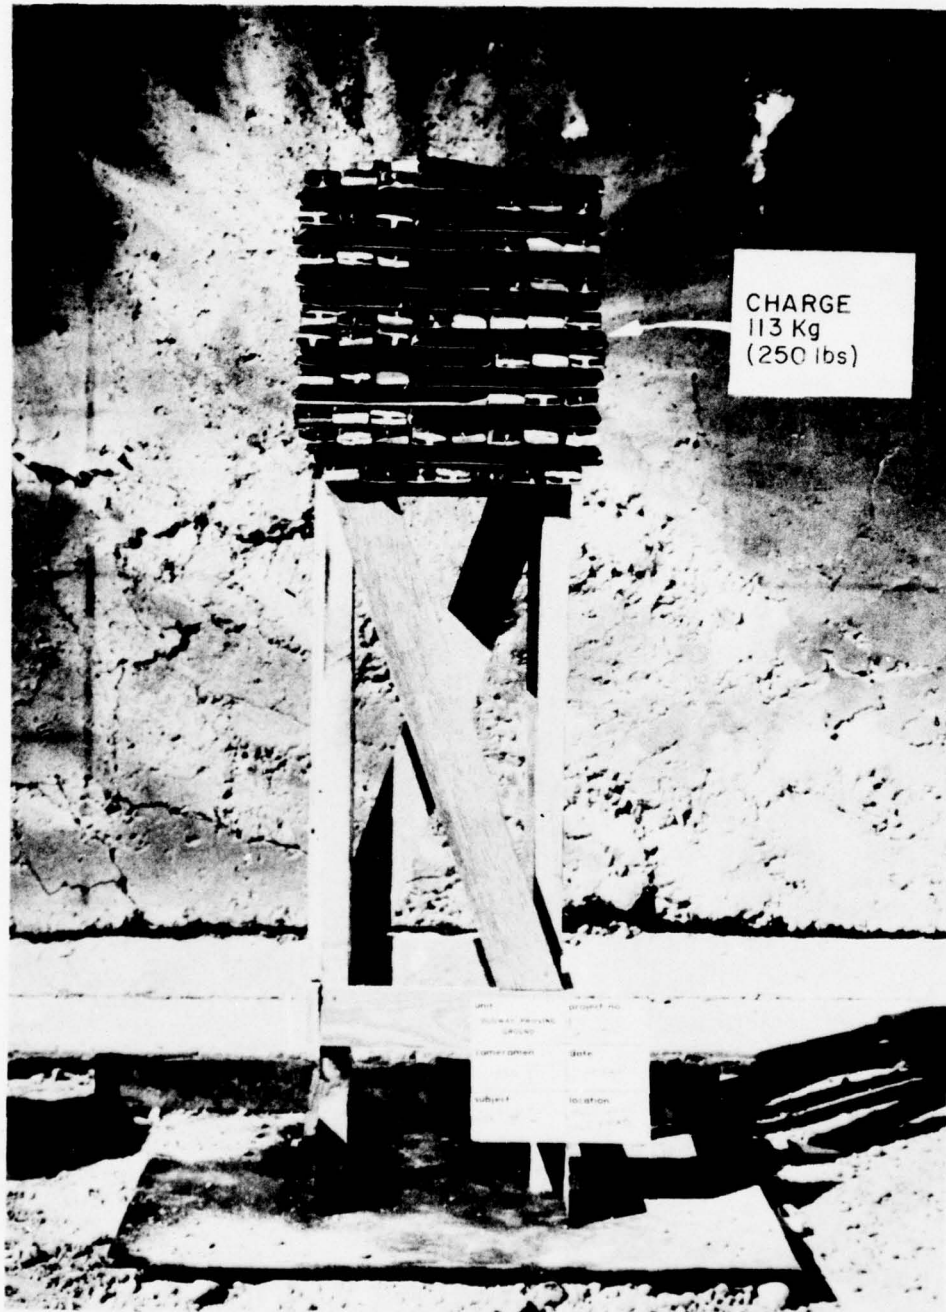
Fig 18 Pre-test setup, Test No. 3

This test was the third and last in a series of tests of Wall No. 1. The explosive quantity involved was 113 kg (250 lbs). The crater in the floor slab produced in the first two tests was covered with a steel plate to minimize enlargement of the crater (Fig 18).

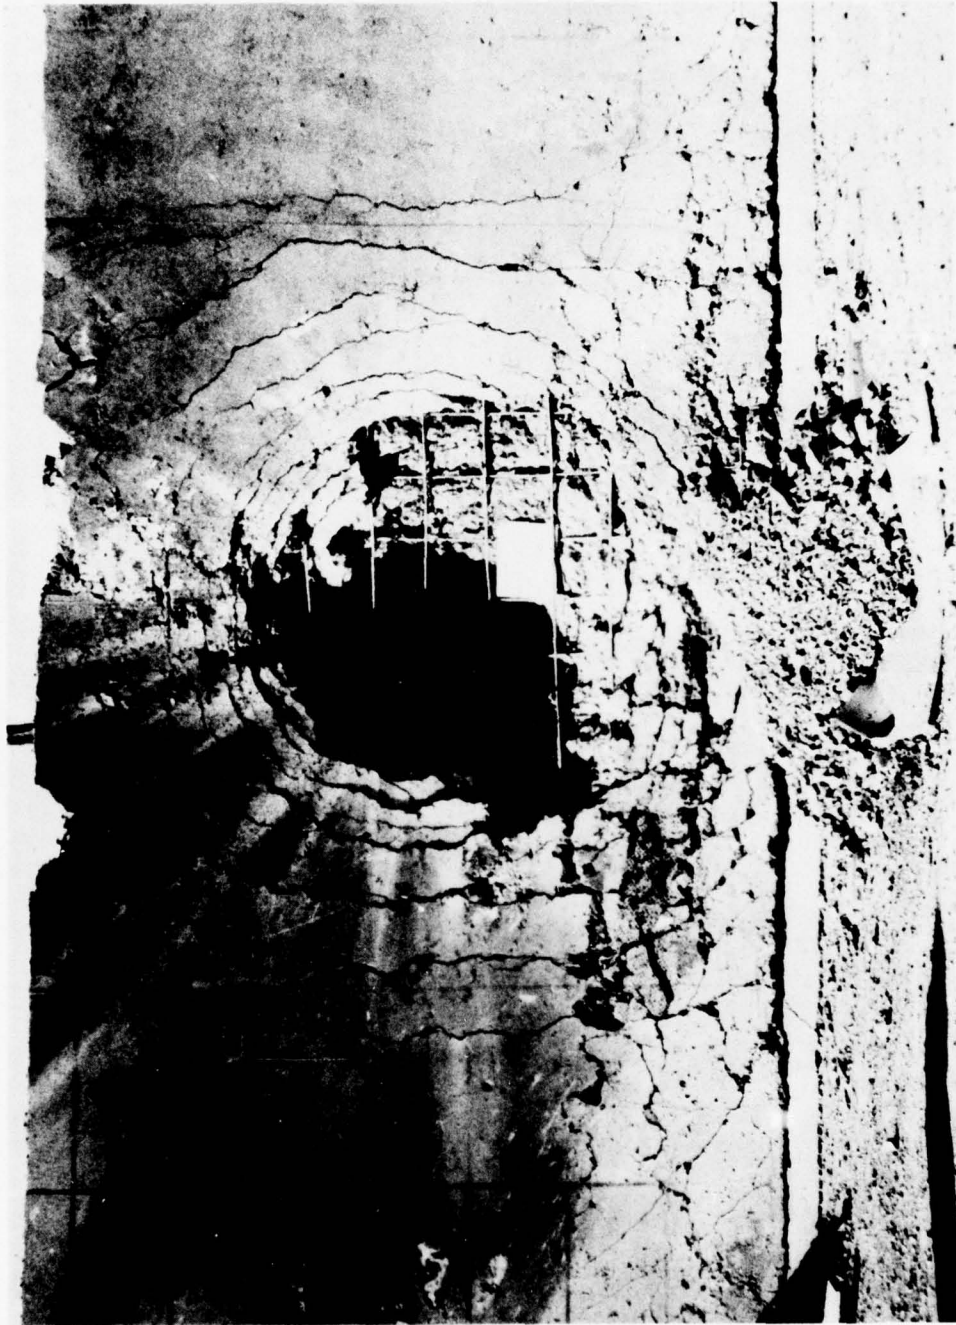
Fig 19 Front face damage, Wall No. 1, Test No. 3

Cratering of the concrete occurred near the center of the wall (Fig 19). The depth of the crater penetrated beyond the depth of the nearside reinforcement, but did not penetrate the

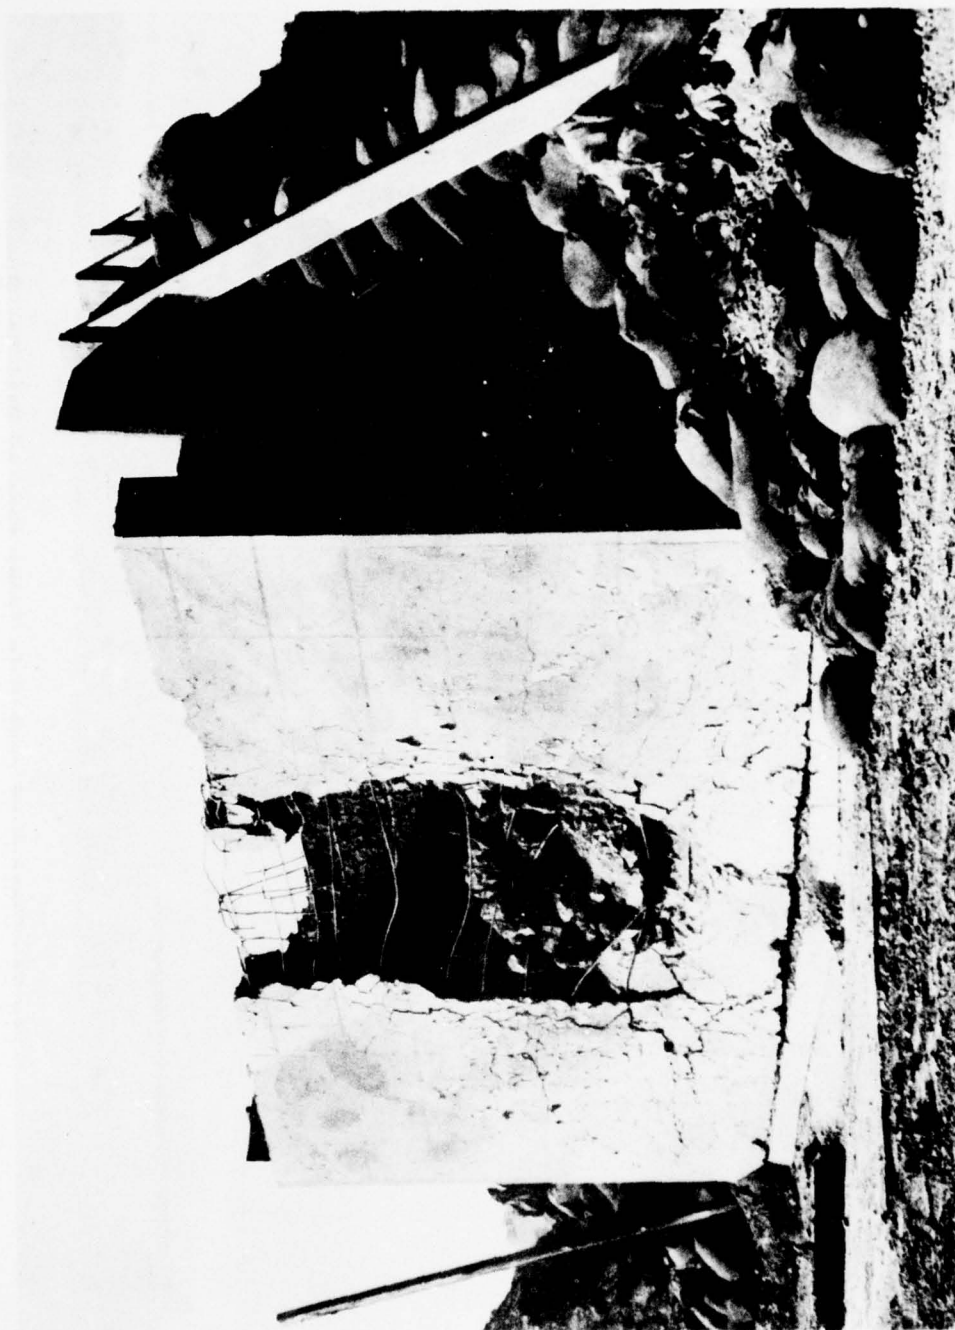
Fig 23 Front face damage, Wall No. 2, Test No. 4

Significant damage was sustained by the wall. The center one-third of the wall was completely destroyed (Fig 23) with the blast pressures penetrating through the earth-mound. The

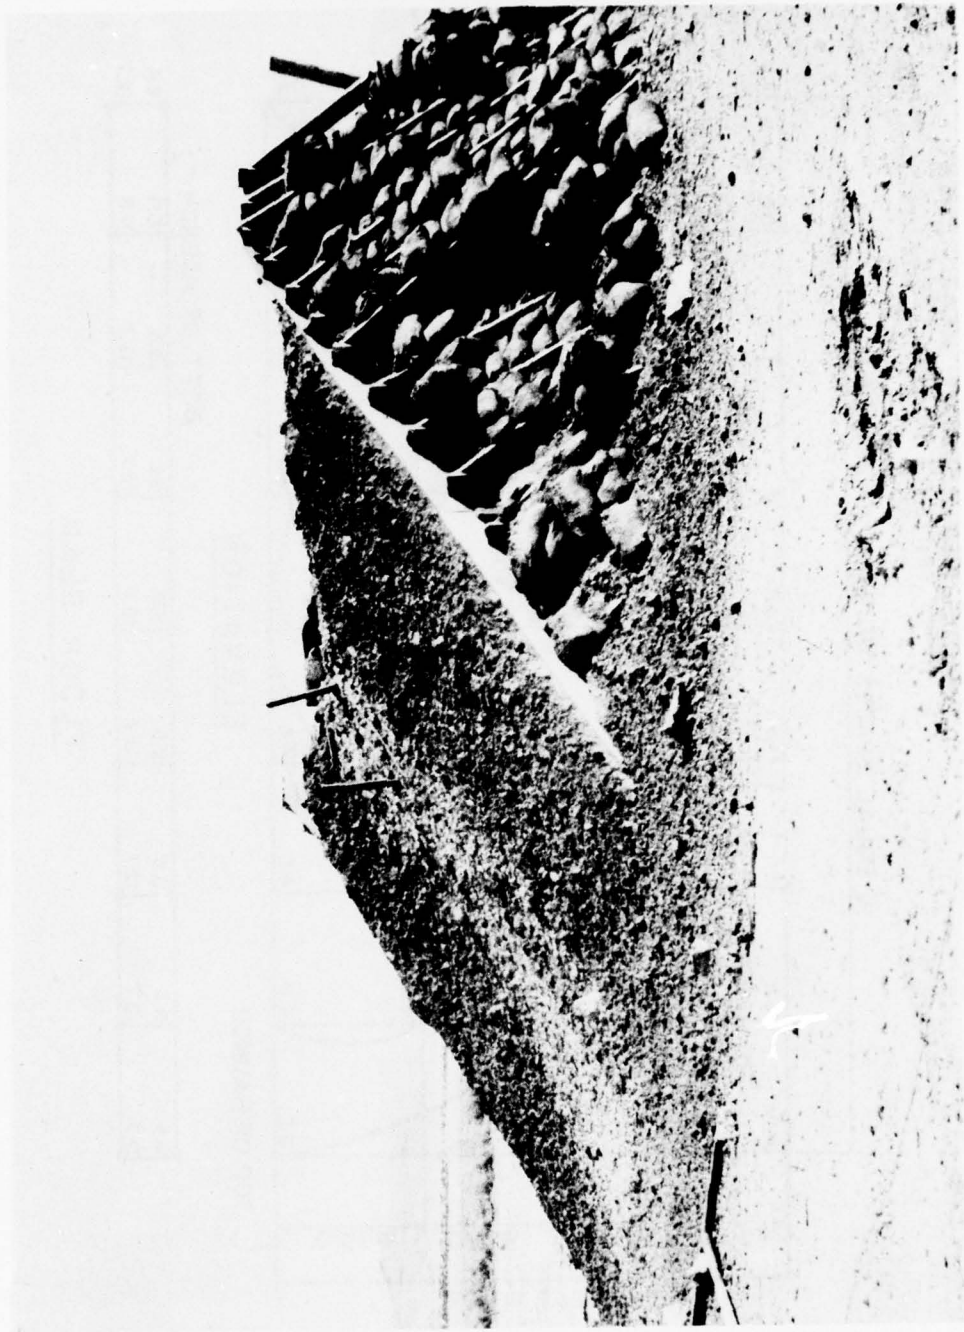
Fig 25 Debris from Wall No. 2, Test No. 4

Figure 25 illustrates the debris formed from the wall breakup.

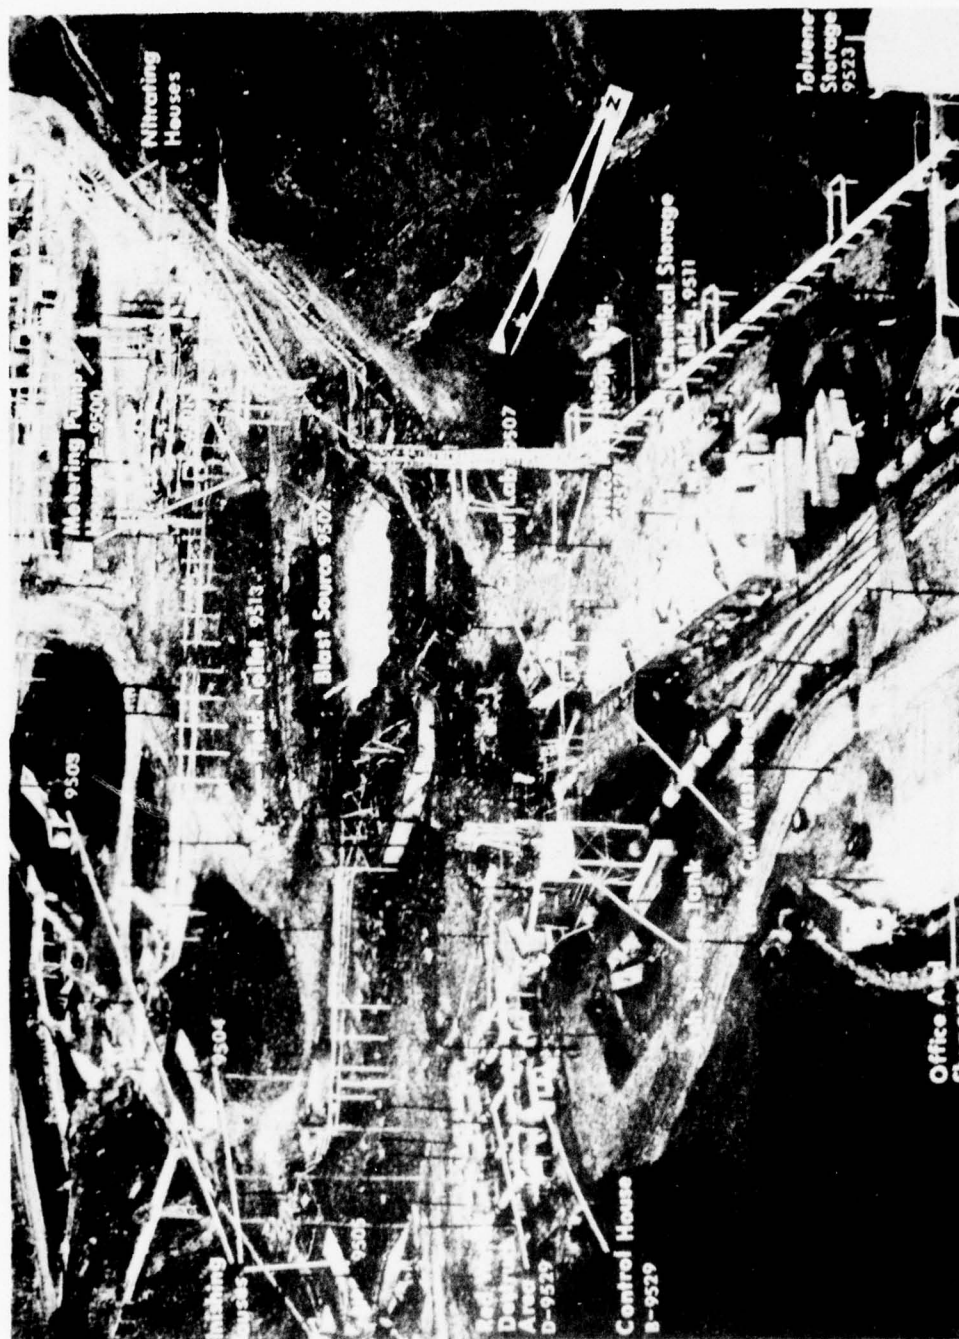
Fig 39 Post-explosion view of Building 9502, RAAP

The total building was destroyed (Fig 39) with only a crater remaining after the explosion. Equipment and the concrete retaining wall fragments, some of which as large as 23 kg (50 lbs), were found as far away as 915 m (3,000 ft).

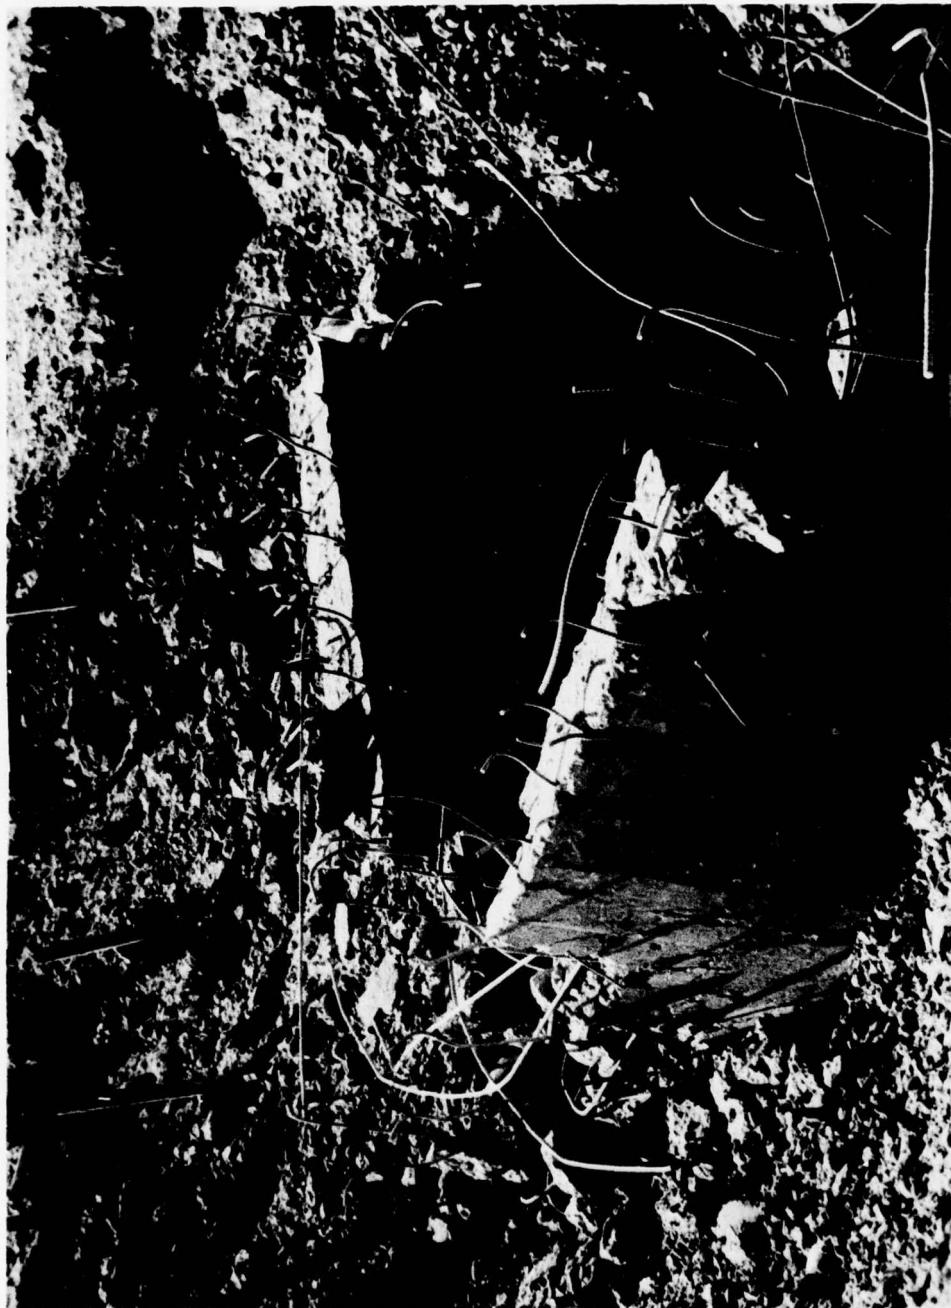
Fig 43 Test Results - Cell No. 2 - Belowground  
Structure Tests

Figure 43 illustrates the above mentioned overall damage to the structure. It may be noted that in addition to the destruction of two walls, the concrete apron at the top of the walls was also destroyed.

After completion of the second test, the cell was completely destroyed with two of the four walls disengaged and dispersed as debris, and the remaining walls severely damaged. Although the
